Class V Underground Injection Control Inspection Report

Inspection Date/Time: 3/12/14, 1:10 p.m. – 3:28 p.m.

Facility Name: Upper Skagit Indian Tribe Water Reclamation Facility

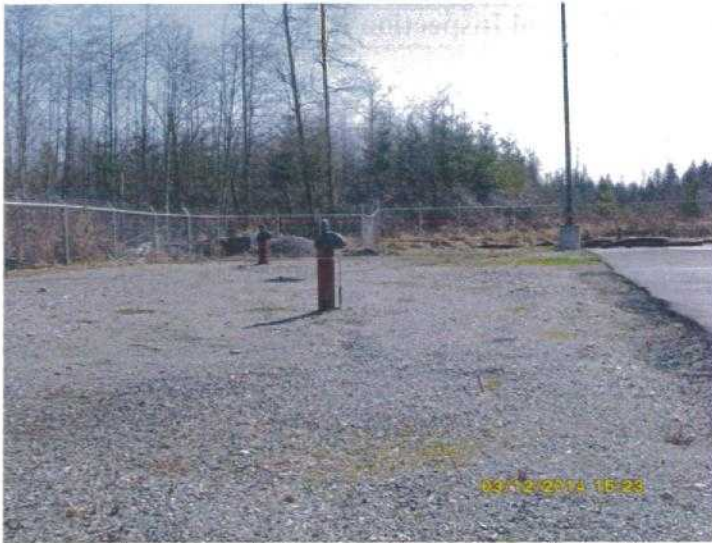
According to the facility representatives, well 1 was the only injection well in active use during this inspection. They told me that well 2 was taken offline about a year and a half ago because sand had entered the well and caused fluids to back up. They explained that they fully rehabilitated the well by removing the sand and a video investigation was also conducted. However, it has not yet been turned back on to receive the effluent. They also told me that since the two wells are of the same design they are actively checking well 1 to see if it has the same sand infiltration issues by continuously monitoring the water level and checking it every quarter to see if sand is entering it, but to date they have not identified any signs of sand infiltration in well 1.

Photo: Injection wells 1 and 2. The active well (well 1) is in the foreground.

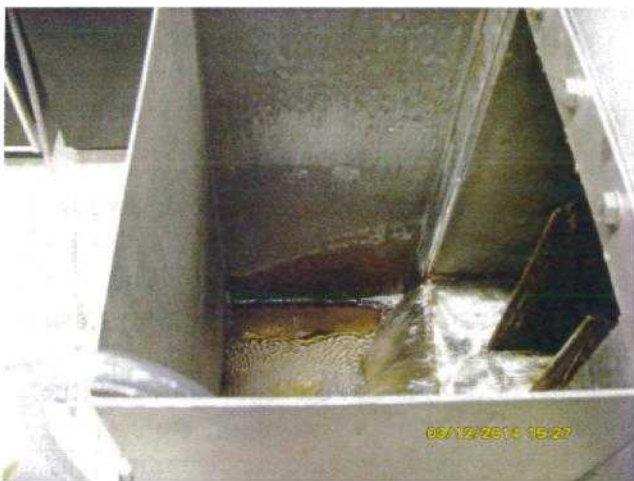
Photo: Sampling port.

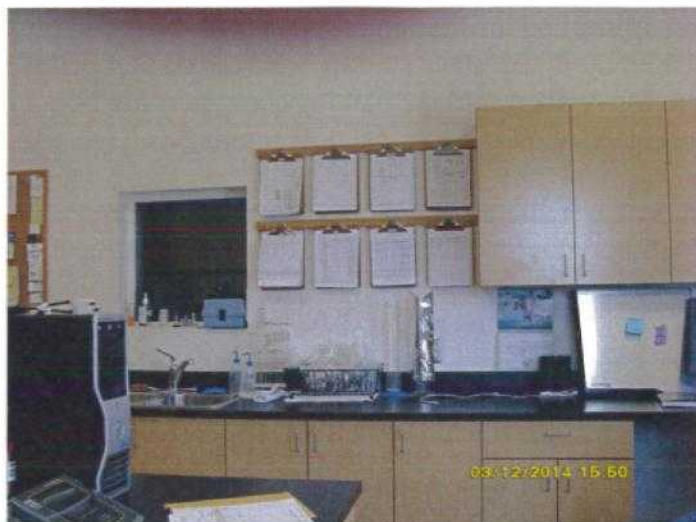
Photo: Bench sheets in use by operators to track sampling and record monitor readings.
